# Revista ALCONPAT

## Experimental evaluation of colored HSC column in fire conditions.

C. Britéz<sup>1</sup>, P. Castro-Borges<sup>2</sup>, A. Berto<sup>3</sup>, P. Helene<sup>1</sup>

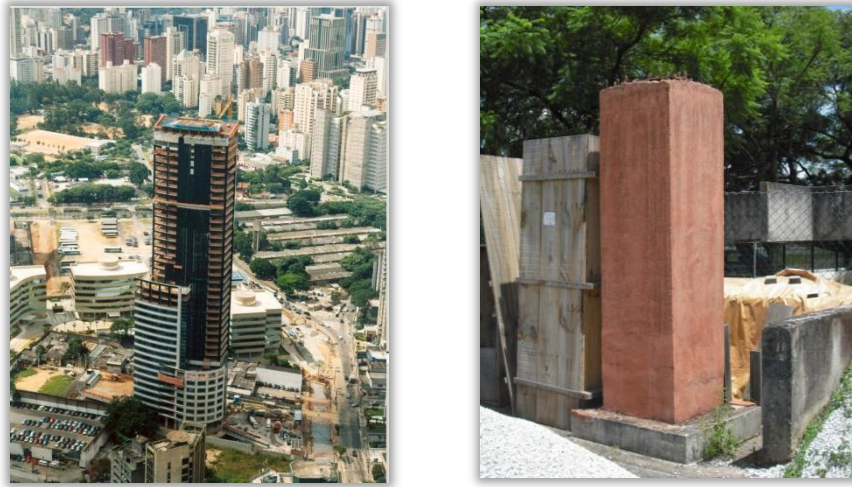
Figure 1. (a) *e-Tower* building, 162m high; (b) HSCC prototype replica, cast at the EPUSP laboratory yard, São Paulo, Brazil

Recently, Brazil was recognized internationally by breaking the record of cast-in-place high strength colored concrete, HSCC, which was employed in several columns of the *e-Tower* building in São Paulo City at the southwest region of the Country (Hartmann; Helene, 2003). When *e-Tower* was built in 2002, some replicas of these columns were cast-in-place at the yard of the Escola Politécnica of the University of São Paulo *EPUSP* (Figure 1) to serve as prototypes for future tests regarding mechanical behavior, durability and fire simulation.

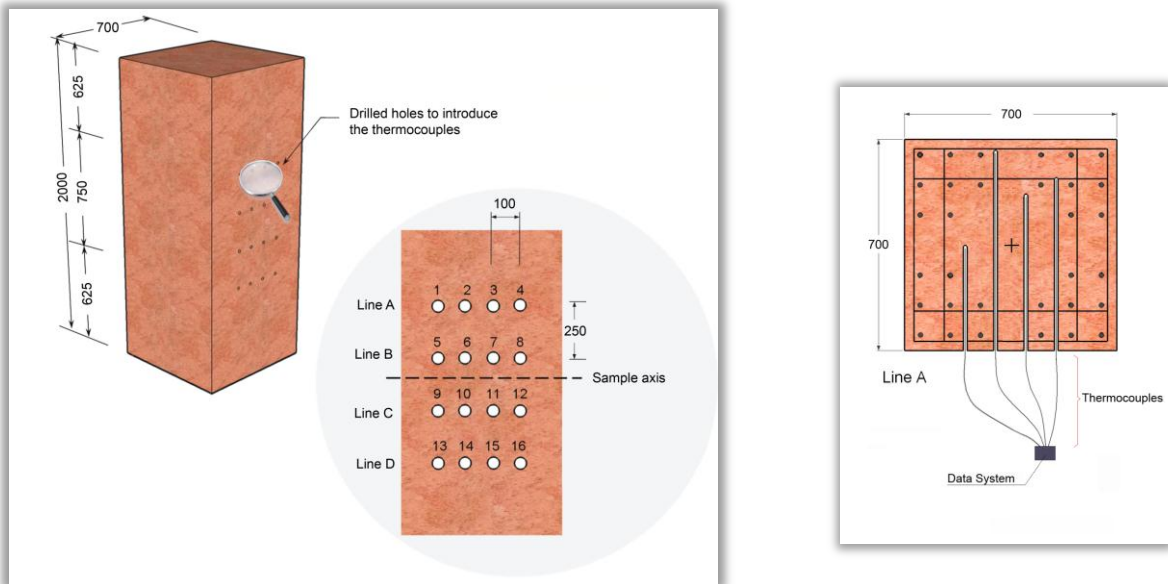
Figure 4. Thermocouples: position and depths (mm) on HSCC prototype-column

Thermocouples embedded inside the prototype column were installed in the region close to the central axis of one of the faces of the column, in four independent lines and with random depths and each line always had four different depths. In all sixteen K-type,  $\phi = 3\text{mm}$  thermocouples were installed with an AISI 316 stainless steel sheath (Figure 4).

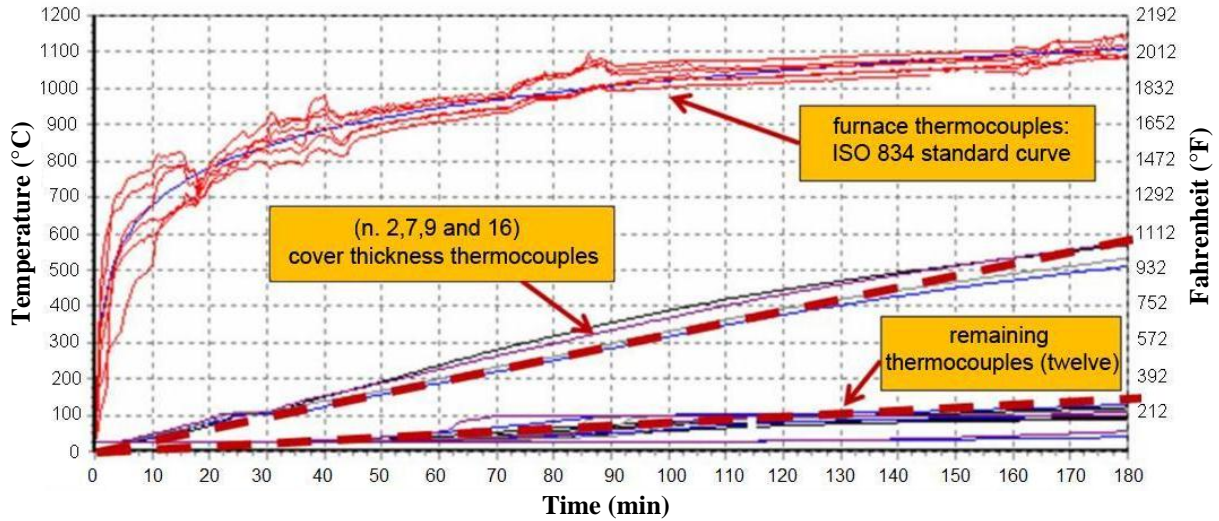
Figure 7. Temperature history in furnace (fire standard ISO 834) and inside the HSCC specimen.

During the 180min (3hr) fire test, six thermocouples monitored the ISO 384 standard curve evolution inside the furnace and other sixteen thermocouples monitored heat propagation inside the prototype column (embedded). Heat propagation (Figure 7) at column interior was uniform according to the depth of the thermocouples. It is possible to observe (Figure 8) that at 180min the thermocouples positioned at the rebar cover depth (25mm from the surface) did not registered temperatures higher than 600°C although inside the furnace, temperature was about 1100°C. In this case, the low heat diffusion and the consequent high thermal gradient could be attributed to the coarse aggregate type (basalt), which has favorable thermal properties when exposed to heat (*fib* Bulletin n° 38, 2007).

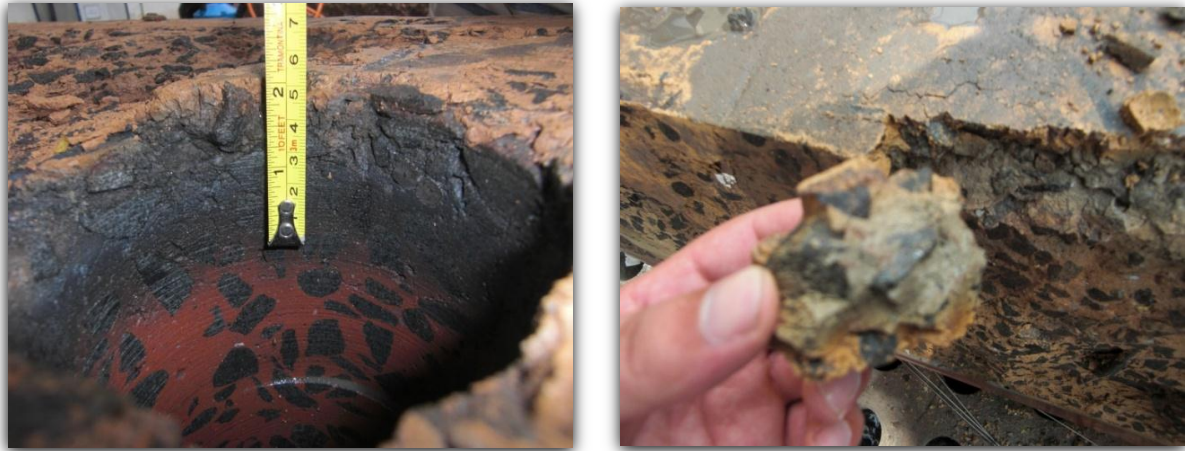
Figure 9. Colorimetric index prototype column.

In this case, principally due to the geometry and the size of the transversal size of the column, as well as the conditions of the experiment (slightly reducing atmosphere and a long exposure time to fire), it was verified that at least a depth of 55mm of the specimen showed a darker or black coloration at the central part of the sides and also that color alteration was not so evident at the

column surface and at some depth of the corners (Fig. 9), where color was less dark and a more faded (orange hue).

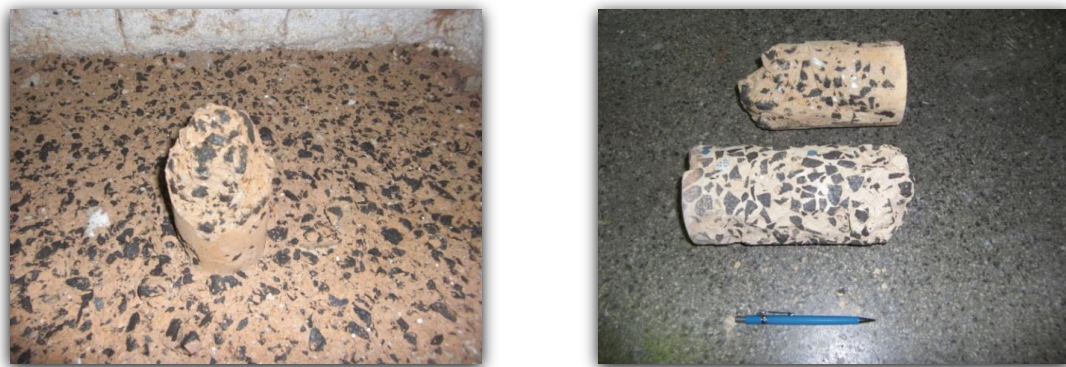
Figure 15. Small cylindrical unreinforced HSC specimens partially disintegrated after fire testing; they had been placed together with the large prototype column.

2. It should be observed that in this experimental program, just as an example, three cylindrical (100mm x 200mm unreinforced concrete specimens and with the same age and mix concrete, were placed inside the furnace, which were in general disintegrated (see Figure 15) after 180min (3hr) of fire testing. Thus, it is recommended that small unreinforced concrete specimens not be utilized to evaluate spalling. Although they are useful for evaluating thermal concrete properties at different temperatures, they are not recommended to evaluate spalling of structural concrete members, as they may underestimate, in some cases, the high strength concrete performance in fire situations;
