Reinforced concrete in marine environment: Effect of wetting and drying cycles, height and positioning in relation to the sea shore

M.H.F. Medeiros^{a,*}, A. Gobbi^a, G.C. Réus^a, P. Helene^b

^a Department of Civil Engineering, University of Paraná, Brazil

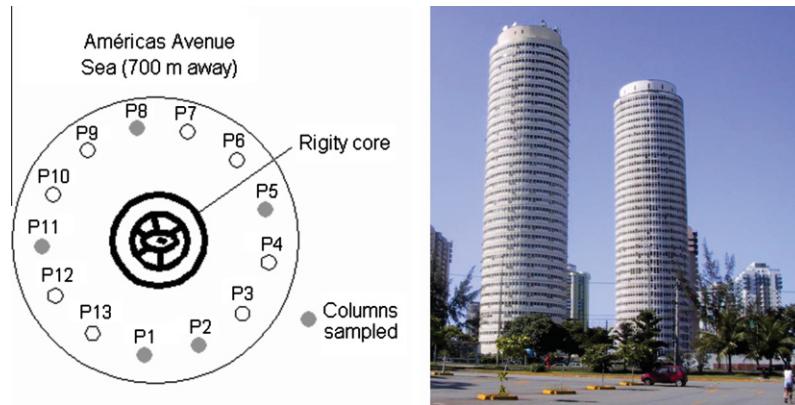
Fig. 1. Building overview and sampled pillars position in relation to the coastline.

Summarizing, five out of the thirteen pillars of the building were chosen, as shown in Fig. 1, considering the position in relation to the coastline. Two pillars facing the coastline were sampled (P1 and P2), and the other three were distributed in order to have one for each side of the building (P5, P8 and P11).

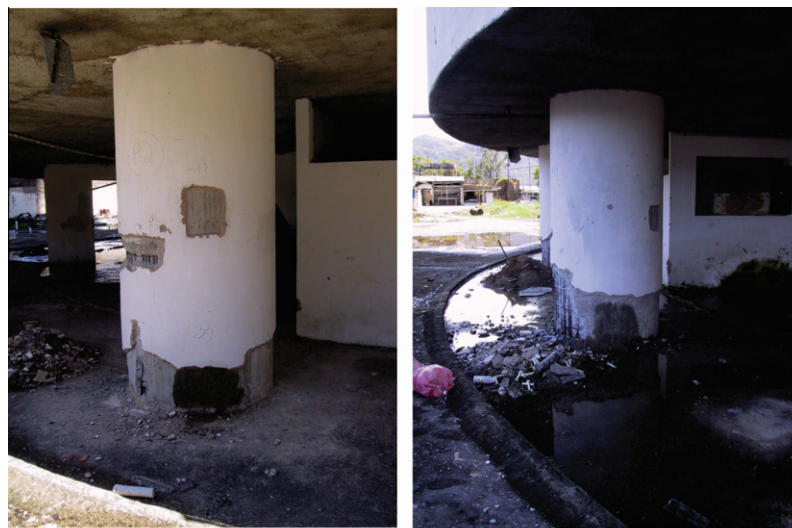
Fig. 2. Water ponding around some pillars of the ground level.

On the ground floor, there are pillars that tend to have rain water ponding and others where this does not happens (see Fig. 2). This happened due to drainage deficiency on the ground floor slabs. For this reason, we opted for sampling involving both cases. In addition, pillars facing different sides of the building were analyzed to verify if their orientation to the sea had some influence.

(a) P2 column, without water ponding. (b) P8 column, with water ponding.

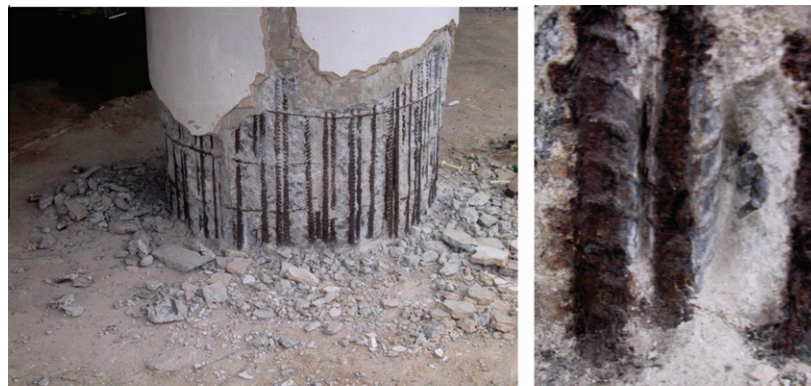
Fig. 3. Deterioration of the pillars on the ground floor.

It is worth stressing that the pillars that presented corrosion reinforcement problems were located on the ground floor indicating a high degree of corrosion, as shown in Fig. 3.

(a) corrosion at the column base at the ground level. (b) corrosion cell formed.

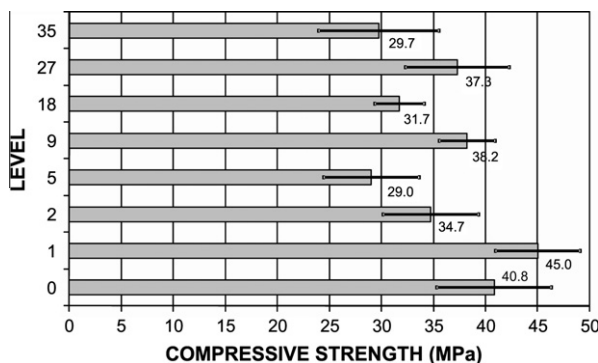
Fig. 4. Compressive strength for each level.

The two tests are presented here to characterize the studied concrete pillars. Fig. 4 shows the average compressive strength for each level, that varied between 29 MPa and 45 MPa and it is clear that the higher values occurred in ground and first levels. This is consistent because those are the levels with larger loading. However, the values did not follow the logic of increasing or staying

constant from the lowest level to the highest one. Furthermore, Fig. 4 shows a high variability in data related to the average value. This may be a sign of low quality control implemented in this building that was made in the 1970s, a time when, in Brazil, the execution control standards were still undeveloped.

The project resistance values on that time went from 15 to 20 MPa. Besides, quality control was low and this probably was compensated with the specification of concretes with much higher compressive strengths than the one considered in the structural calculation. It was an uneconomical conduct, however favoring safety and needed due to the large quality variability of the concrete used in the construction site.

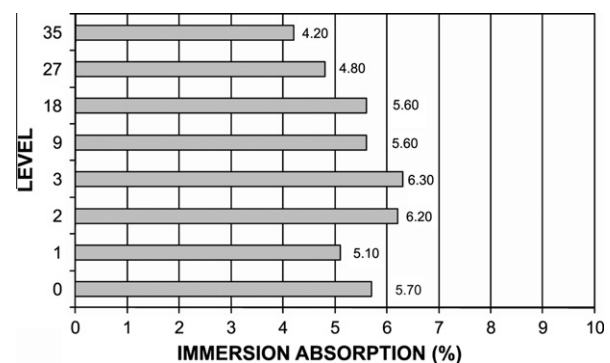
Fig. 5. Immersion absorption for each level.

Fig. 5 shows results of immersion absorption for each pillar. The values are between 4.8% and 6.3% and correspond to low-absorption concrete. This is related with what was previously explained, that the concrete was over dimensioned somehow to compensate the large dispersion of concrete quality. This, somehow, resulted in the reinforced concrete suffering lower degradation during this exposition period in an environment close to the sea.

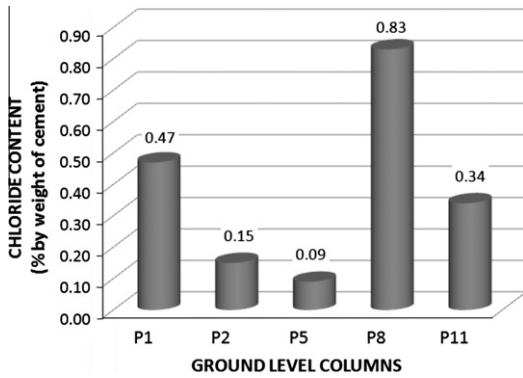
Fig. 6. Chloride content (by weight of cement) at ground level pillars.

Fig. 6 shows that the highest chloride contents occur in pillars submitted to wetting and drying cycles (P1, P8 and P11). This indicates that this is a highly relevant factor concerning ion penetration in a reinforced concrete structure. This is in accordance with data found by Meira et al. [11] and Costa and Appleton [26].

Pillar orientation does not seem to greatly influence chloride penetration because P2 did not present high level of chloride contamination even facing the sea. Thus, the data indicate that probably the occurrence of wetting and drying cycles is more important than the pillar position in relation to the sea.

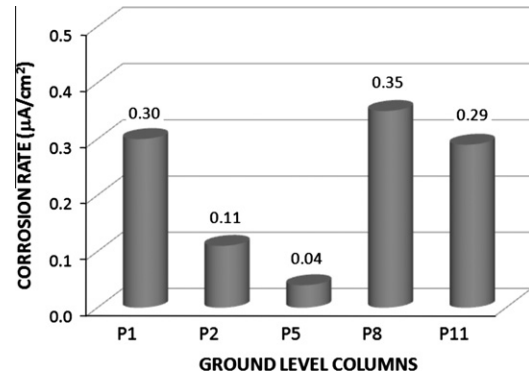
Fig. 8. Corrosion rate (µA/cm²) at ground level pillars.

Concerning the corrosion rate reading, the data follow the same tendency, with pillars P2 and P5 classified as negligible corrosion level, while pillars P1, P8 and P11 are classified as low corrosion level (see Fig. 8).

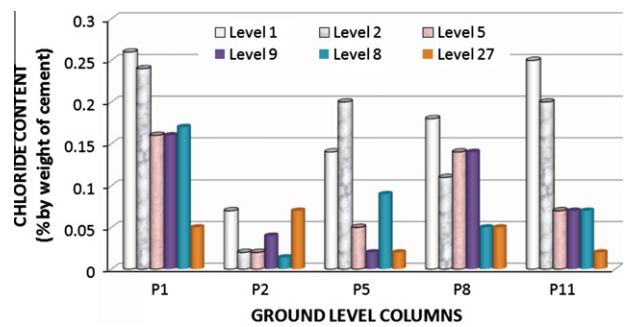
Fig. 9. Chloride content (by weight of cement) X levels (level 1–27 and pillars P1, P2, P5, P8 and P11).

Fig. 9 presents the chloride content results obtained from the different pillars at each sampled levels. Compared to results obtained from the ground level, it can be seen that the chloride contents of this level are far higher than those found on other levels, a fact probably associated to water ponding occurring around the pillars base, originating wetting and drying cycles, which contribute to the easier ingress of chloride-ions [7], as can be seen in Fig. 2.

The results of Fig. 9 show that the greater the height, the lower the chloride content level related to cement mass is. This does not happen in all the cases, but it is to be expected, because it is a real

Fig. 9 shows that another important issue to be highlighted from these data is that again the position in relation to the sea was not a high influence factor in the contamination degree of the structure. P2 had lower chloride content as compared to others pillars and P1 had the same level of chloride content as the others pillars.
