## Watertightness in anti-flotation slabs. MIS-RJ Case

### *Estanqueidade de lajes de subpressão. Caso MIS-RJ*

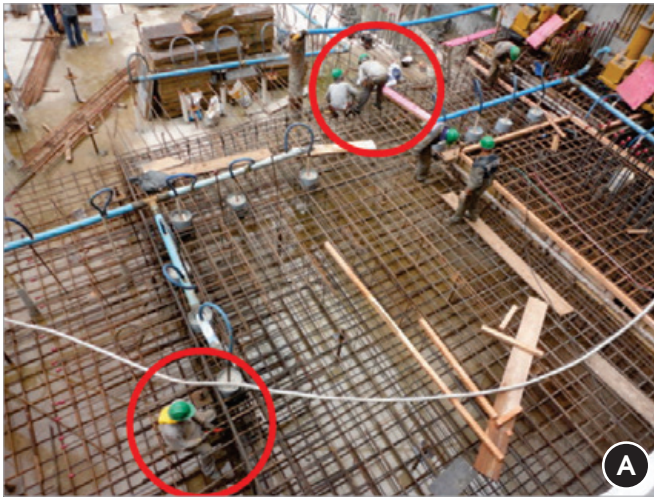
Figure 3 – Typical details of anti-flotation slab concreting joints along the 10 concrete placing phases

Detail of preplacement step: poultry wire mesh adjustment at designed joint

per face, as can be seen in Figure 2. The same procedure (tapes) was implemented at reinforcing slabs intersection with diaphragm walls. Figure 3 exemplifies actual situation at worksite before, during and after concreting a generic phase.

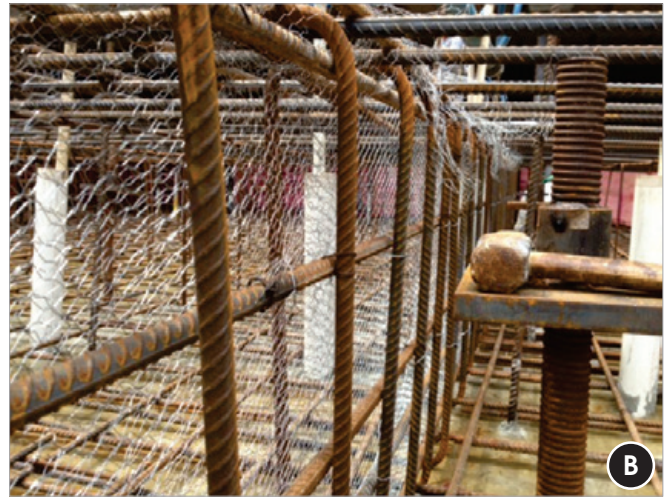
Detail of concreting joint with poultry wire mesh and external reinforcement support

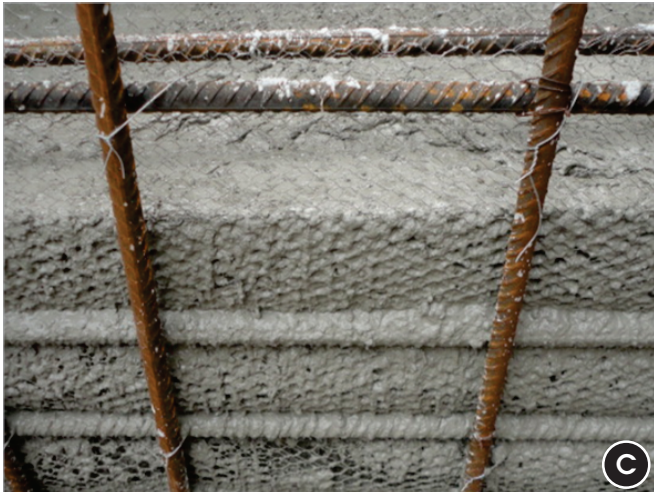
Detail of poultry wire mesh performance during concrete placing: minimal cement slurry leakage

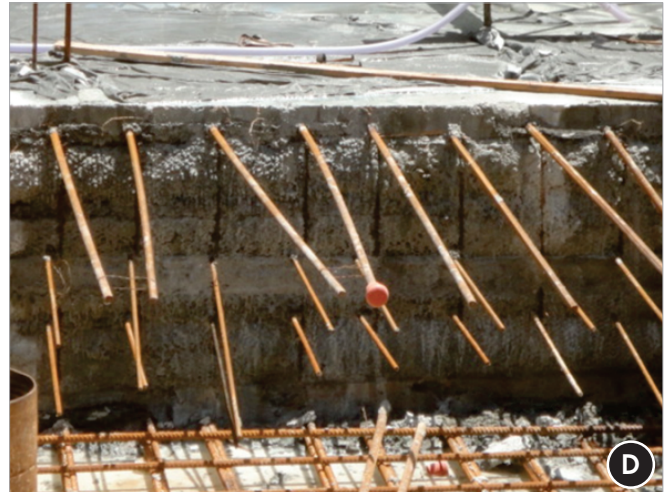
Detail of concreting joint before hydro swelling tape placing: vertical and rough surface, the next slab reinforcement not yet finished

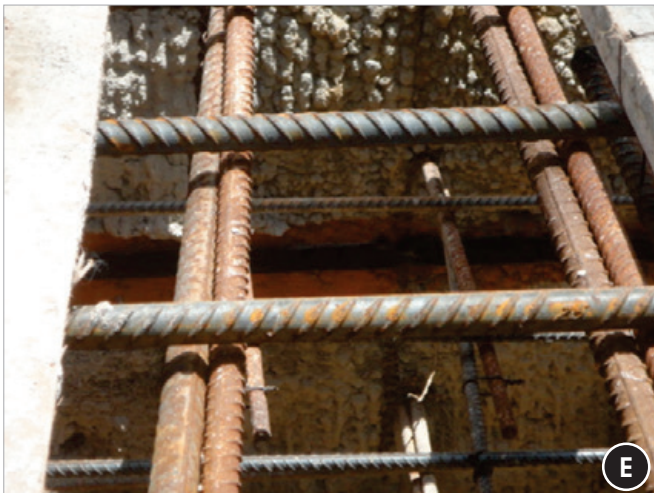
Detail of hydro swelling flexible tape already placed for next concreting procedure: reinforcement for next concreting phase is totally completed

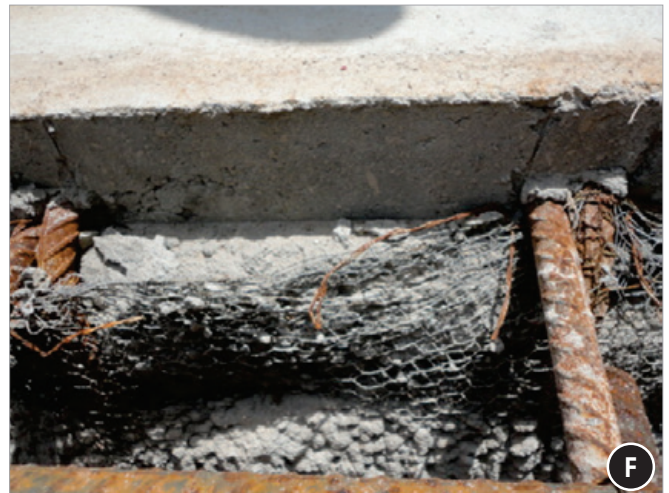
Detail of finishing obtained by upper wooden support barrier, wire mesh just underneath, will yet be cut

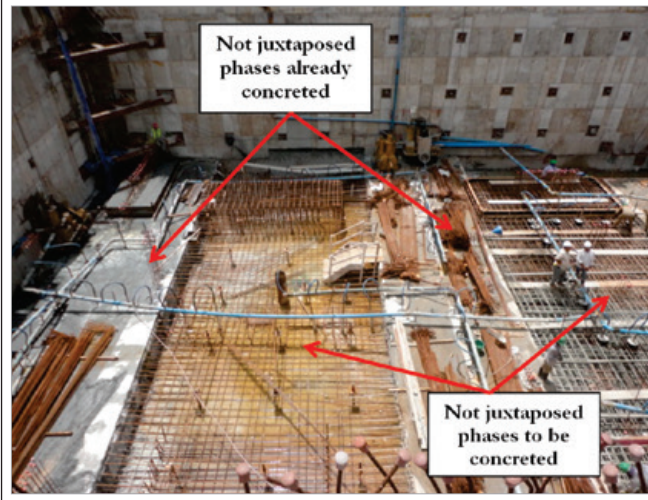
**Figure 4 – Not juxtaposed (intercalated) concreting phases**

Thus, it was planned that no juxtaposed concreting phases were held together, which provided the maximum possible number of free slab sides. Besides this, it was recommended a minimal time interval of one week between juxtaposed concreting phases, which did not mean cast two phases simultaneously, if not

juxtaposed. In this way, the temperatures originated by cement hydration exothermal reactions should be decreasing and, consequently, deformations associated to this phenomenon will be minimized. These measures, notwithstanding, had no impact on project time-schedule, enabling an effective production of approximately 20m<sup>3</sup>/h, which means that 1200m<sup>3</sup> of concrete were placed in 60 hours divided into 10 different concreting events. This concreting plan, in not juxtaposed (intercalated) phases, can be observed in Figure 4.

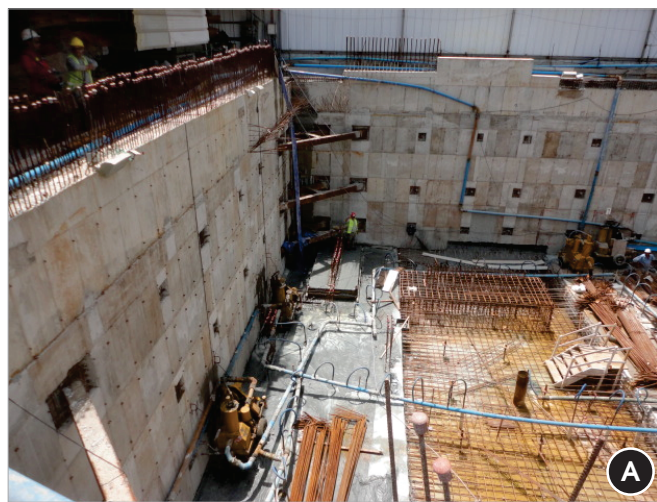
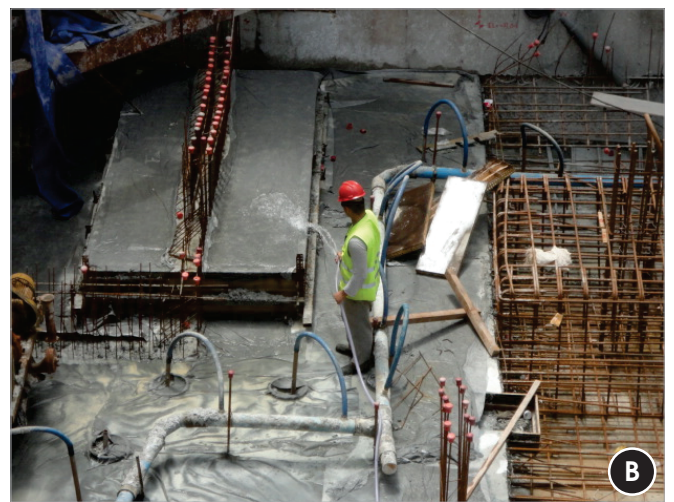
**Figure 5 – Detail of concreted phase, joint to the reinforcing wall, with a curing mat over the surface and of curing procedure (mat being soaked)**

After some hardening of concrete (by touch), the whole surface was covered with a mat soaked with water, which was maintained pressed against the surface of the concreted phase, sprayed with drinking water each 2h at most. This mat was always saturated at the end of the working time to ensure that it would remain humid during night and again early in the following morning, at beginning of work. This careful curing procedure was maintained at least for 7 days (up to the probable next phase concreting date). The curing procedure (a mat being soaked) can be seen in Figure 5. The curing mat employed was 100% polyester with an adhered perforated polyethylene film, manufactured by BIDIM, line Bidim CC-10 type.

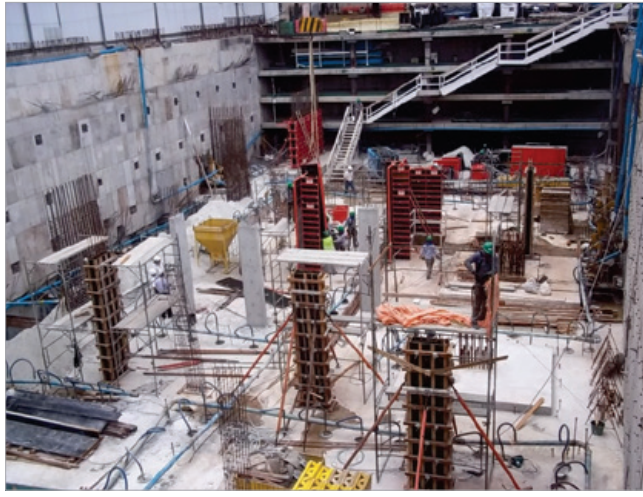
**Figure 6 – Anti-flotation slab already finished and beginning of formwork erection of 2nd basement columns (some of them already concreted)**

this context, it shall be remarked that during and after finishing the ten phases, no fissures of any kind were detected through which water could percolate. The already finished anti-flotation slab can be seen in Figure 6, with formwork for 2nd basement columns already erected.

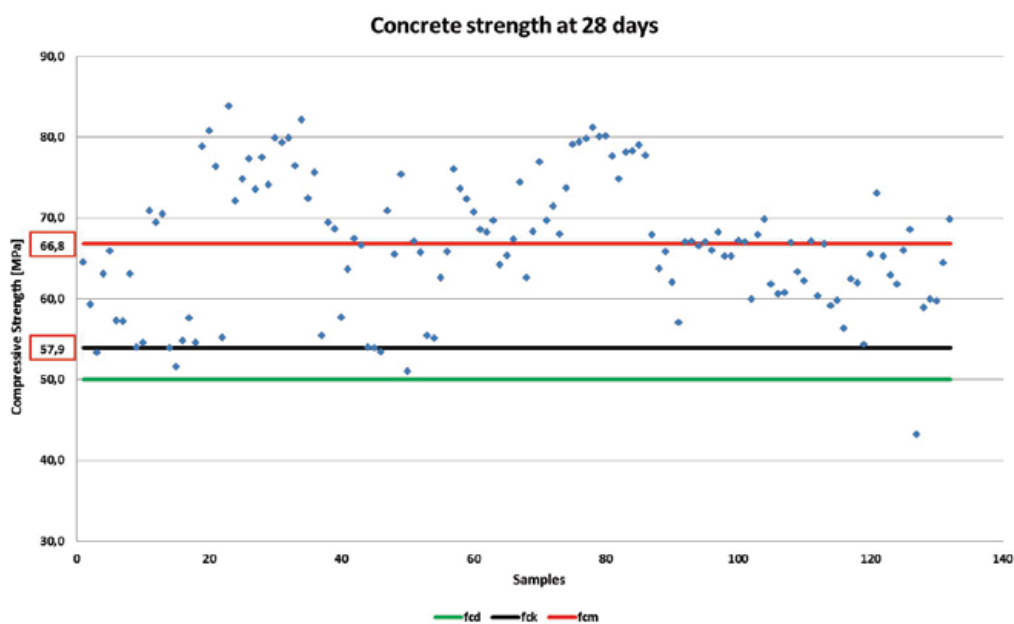
**Figure 7 – Results of concrete compressive strength at 28 days**

An exhaustive concrete technological control was established for the slab –total sampling (100%) – as mentioned above. Of all mixing trucks, only one was identified as having compressive strength below design specification, with a value of 43,2MPa. This value was submitted to the structural engineer, who approved it, by new calculation, not being needed any additional structural reinforcement. Graph at Figure 7 presents the results of concrete compressive strength at 28 days old. It can be seen that there was an excessive dispersion, which probably was associated to errors when pouring cylinders or during compressive rupture test, in short, related to technological control procedures. Later on, by means of a more refined statistical analysis, the anomalous results were abandoned.
