TECHNICAL PAPER

Engineering field tests for alkali-aggregate reaction

The Paulo Guerra Bridge in Recife, Brazil, was constructed in 1977. After about 15 years some pathological symptoms appeared, such as map cracking, concrete expansion, steel corrosion, and leaching stains. This paper presents a discussion of the specific inspections conducted, which included visual observation of the foundation blocks (pile caps), core extraction, ultrasonic pulse velocity tests, carbonation tests, measurements of chloride concentration, electrochemical resistivity, corrosion potential, compressive strength, and modulus of elasticity as well as X-ray diffraction and microscopy evaluations. The results of the inspection showed the occurrence of generalized alkali-aggregate reactions (AARs) on the pile caps (foundation blocks) of the bridge. The recommended repair for the pile caps was confinement to resist tensile stresses of 4 MPa.

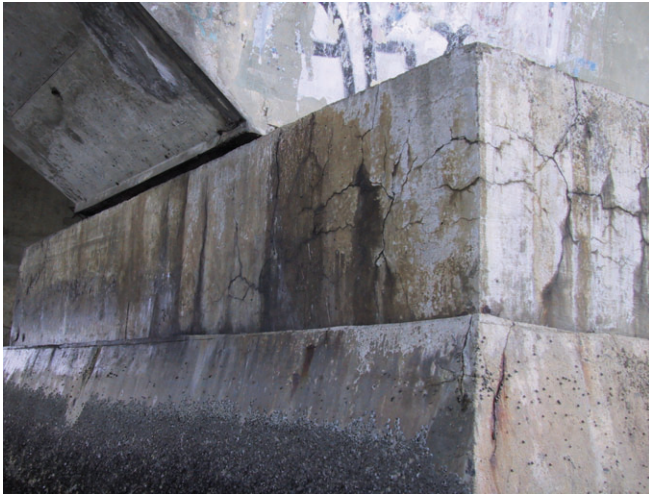
It is therefore not surprising that early signs of deterioration were evident on the deck, superstructure, and substructure about 15 years after the end of construction (Figure 1). This article presents a discussion of the inspection and the recommended repairs to the bridge foundation blocks (pile caps). These blocks were constructed using precast reinforced concrete boxes that served as permanent formwork for cast-in-place footings connecting the bridge piers to the supporting piles. The original project specified a compressive strength of 20 MPa (2,900 psi) for the pile caps, with an expected modulus of elasticity of 21 GPa (3,050 ksi) according to ACI 318-14.²

FIGURE 1 Signs of deterioration at the Paulo Guerra Bridge (foundation blocks, i.e., pile caps).

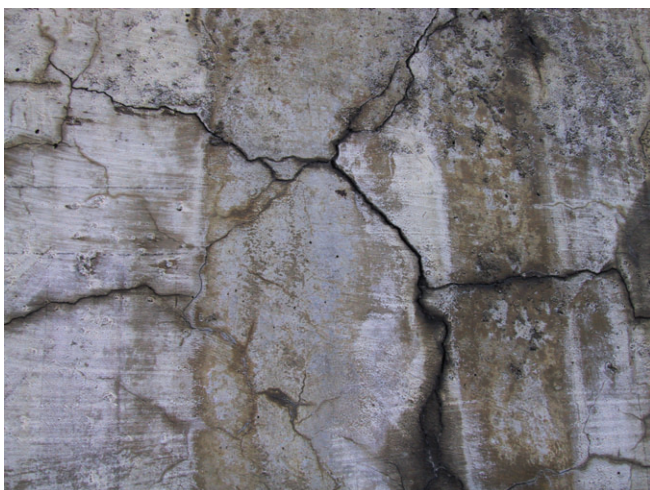
FIGURE 2 Leaching stains and map cracking (foundation block 7).

Stains typical of corrosion and leaching were detected as well as cracks with defined paths (Figure 2).

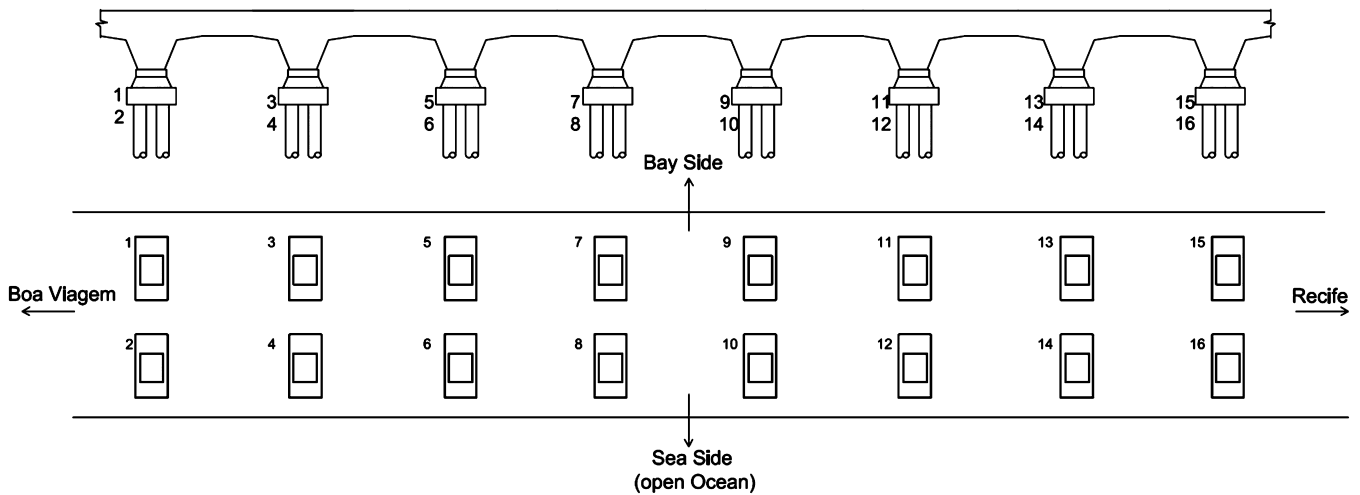
Figure 3 shows schematic view of the bridge showing the relative locations of the pile caps. Of the total of 20 blocks, four are buried in the soil next to the junctions and the other 16 are in direct contact with water. Of these 16 blocks, five were chosen for inspection (blocks 1, 4, 7, 10, and 12), selected according to their condition in order to be representative in relation to the pathological problems evident—from the most deteriorated to those with a better visual appearance.

FIGURE 3 Overall schematic view showing foundation block locations.

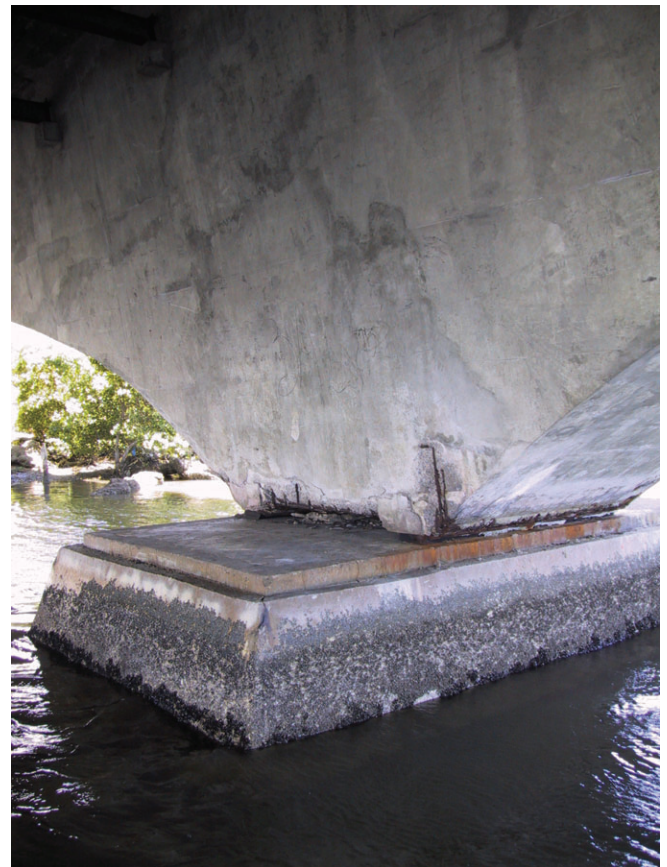
FIGURE 4 Severe steel corrosion on the superstructure of the Paulo Guerra Bridge.

Considering the results obtained in the analyses carried out, it can be affirmed that the two major pathological problems of premature and accelerated aging of the Paulo Guerra Bridge consisted of AAR in the pile caps (foundation blocks), and, consequently, steel corrosion in the bridge's superstructure.
